**Flood Control Project Maintenance
Levee Inspections**
LMA District Cover Sheet
Spring 2018 Levee Inspection Results

Reclamation District No. 2103 Wheatland Vicinity

Spring 2018 Levee Inspection Results

Waterway			Bank	Unit Miles
Unit No. 01 South Dry Creek			Left	4.64
	Spring (March - May)	Summer (June - August)	(September - November) Fall	Winter (December - February)
Unit Maintenance Rating (Fall Only)				
Date of Inspection	4/18/2018 - 4/18/2018			
DWR Inspector	Sterling York			
Accompanied By	Tom Engler RD 2103			
	Joe Conant RD 817

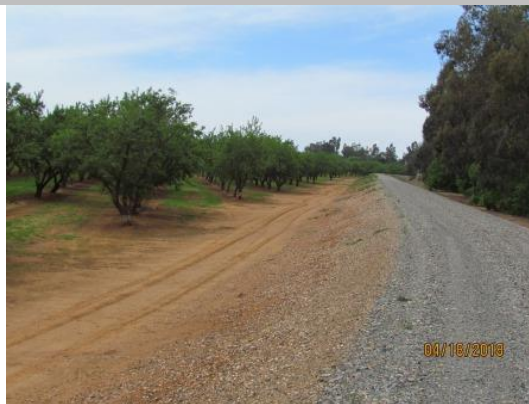
Photo 1 of 1 : SP_2018_RD2103_10_19_20180501_00046.jpg

View looking downstream landside of the maintained annual vegetation,
Spring 2018.

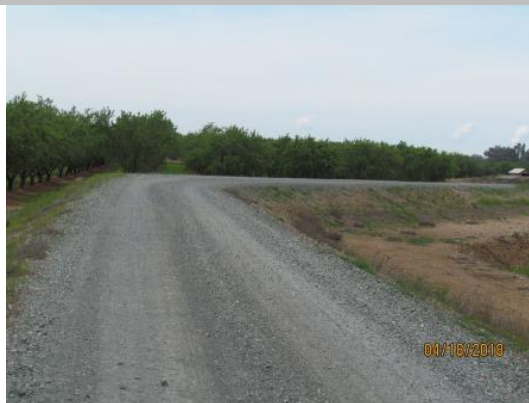
Photo 1 of 1 : SP_2018_RD2103_10_20_20180501_00048.jpg

View looking downstream waterside of the maintained annual vegetation, Spring 2018.

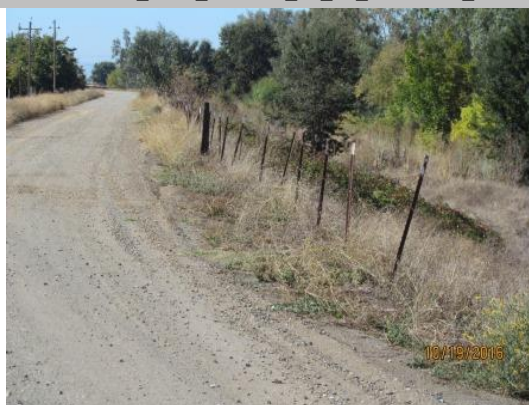
Photo 1 of 1 : SP_2018_RD2103_10_11_20180302_00003.jpg

LM Start	0.01	Rating **	M	Issue No.	11
LM End	0.47	Issue Type +	En	Location *	WS
Category	Earthen Levee			GPS Latitude/Longitude	
				Start	End
Item	Encroachments			39.019849 °	39.021775 °
				-121.453871 °	-121.445642 °
DWR ID	DWR_RD2103_01_f_2013_11				
Comment Code					
FE : Fence					
Inspector Comment					
Fence along waterside hinge point.

View of fence along waterside hinge point looking downstream, still exist Fall 2017.

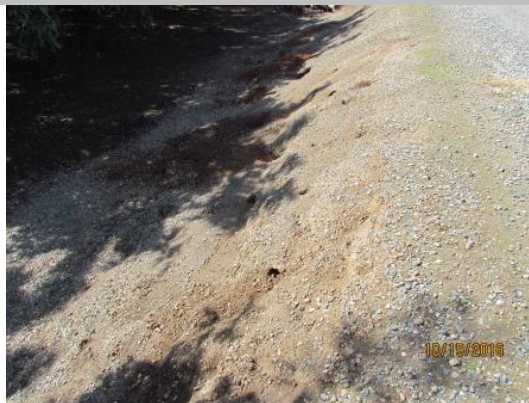
Photo 1 of 1 : SP_2018_RD2103_10_23_20180302_00006.jpg

View of squirrel holes on the waterside looking downstream but no evidence of animal activity during Fall 2017 inspection.

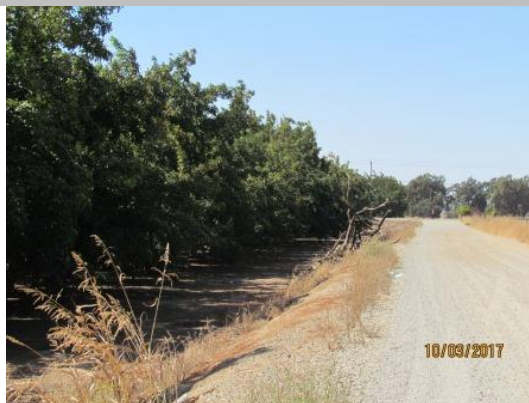
Photo 1 of 2 : SP_2018_RD2103_10_22_20180302_00004.jpg

LM Start	0.22	Rating **	M	Issue No.	22
LM End	0.22	Issue Type +	En	Location *	LS
Category	Earthen Levee			GPS Latitude/Longitude	
				Start	End
Item	Encroachments			39.020937 °	39.020937 °
				-121.450237 °	-121.450237 °
DWR ID	DWR_RD2103_01_f_2015_22				
Comment Code					
PR : Prunings					
Inspector Comment					
Pruning's still exist.

View looking downstream landside of pruning's that still exist as of Fall 2017.

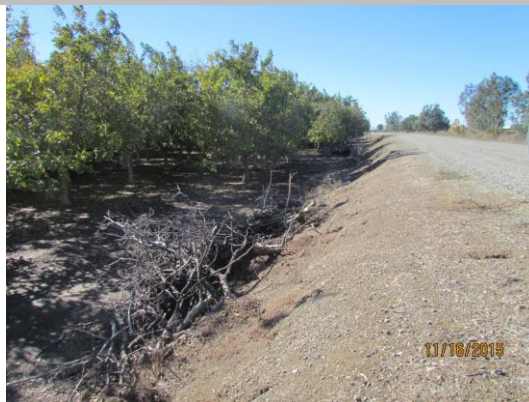
Photo 2 of 2 : SP_2018_RD2103_10_22_20180302_00005.jpg

Pruning's still exist as of Spring 2017.

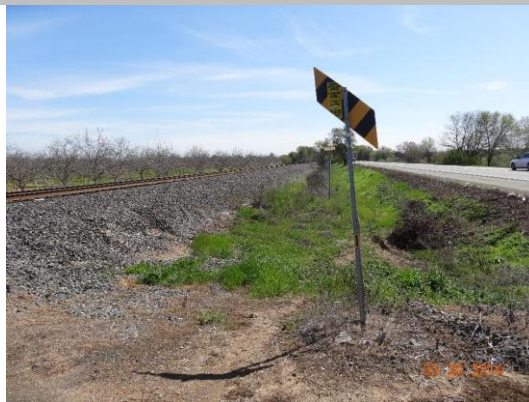
Photo 2 of 3 : UCIP_SP_2018_39985_69851.jpg

Marker visible on toe in between railroad tracks and highway (south).

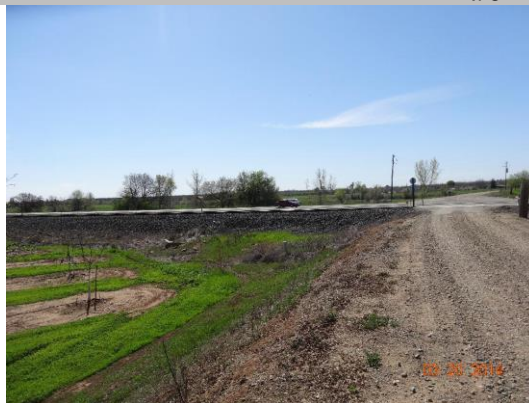
Photo 1 of 3 : UCIP_SP_2018_39987_71885.jpg

LM Start	0.56	Rating **	M	Issue No.	32
LM End	0.56	Issue Type +	En	Location *	
Category	Supplemental			GPS Latitude/Longitude	
				Start	End
Item	DWR UCIP Field Study			39.022665 °	39.022665 °
				-121.444688 °	-121.444688 °
DWR ID					
Comment Code					
Inspector Comment					
FS_ID:39987 DS_ID:24879 EP_NO: N/A Repair Type: Non-Urgent Crossing Status: Indicator Found UCIP Comments: Need to contact owner to obtain depth of line through levee. Also need permit authorizing conduit through levee. FIELD_STRUCT_DESC: Conduit line through levee. Markers visible on both sides. FS Date: 3/4/2014

View of landward side.

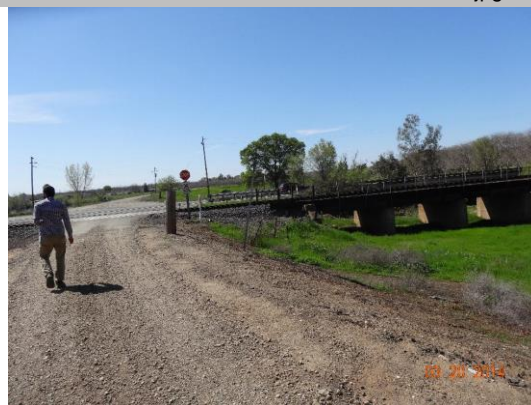
Photo 1 of 3 : UCIP_SP_2018_38323_69860.jpg

LM Start	0.56	Rating **	M	Issue No.	33
LM End	0.56	Issue Type +	En	Location *	
Category	Supplemental			GPS Latitude/Longitude	
				Start	End
Item	DWR UCIP Field Study			39.022733 °	39.022733 °
				-121.444626 °	-121.444626 °
DWR ID					
Comment Code					
Inspector Comment					
FS_ID:38323 DS_ID:19469 EP_NO: 2098 Repair Type: Non-Urgent Crossing Status: Indicator Found UCIP Comments: Need to contact owner to determine status of crossing. Need date of last inspection and confirmation that crossing is still in operable condition. FIELD_STRUCT_DESC: 16-inch steel gas line through the levee, 3 feet below the crown. Marker on waterside (WS) slope. (16-inch line authorized under Permit No. 2098, 1955-Pacific Gas and Electric Company [PG&E]). [Additional Reference(s): DWR Levee Logs, 2005. USACE Sacramento O&M Manual Unit No. 146, November 1962, (HLM 0.56)] FS Date: 3/20/2014

View of levee crown at crossing.

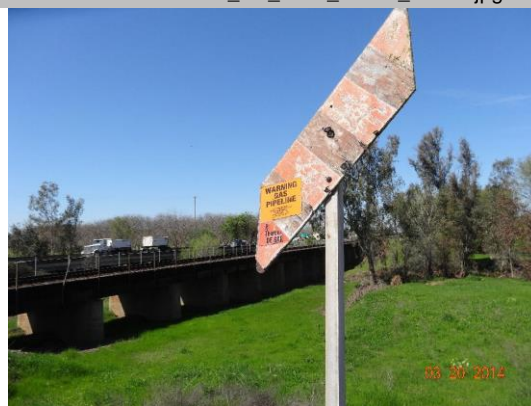
Photo 2 of 3 : UCIP_SP_2018_38323_69859.jpg

Comment Code						
Inspector Comment						
FS_ID:38323 DS_ID:19469 EP_NO: 2098 Repair Type: Non-Urgent Crossing Status: Indicator Found UCIP Comments: Need to contact owner to determine status of crossing. Need date of last inspection and confirmation that crossing is still in operable condition. FIELD_STRUCT_DESC: 16-inch steel gas line through the levee, 3 feet below the crown. Marker on waterside (WS) slope. (16-inch line authorized under Permit No. 2098, 1955-Pacific Gas and Electric Company [PG&E]). [Additional Reference(s): DWR Levee Logs, 2005. USACE Sacramento O&M Manual Unit No. 146, November 1962, (HLM 0.56)] FS Date: 3/20/2014

Marker visible waterward side.

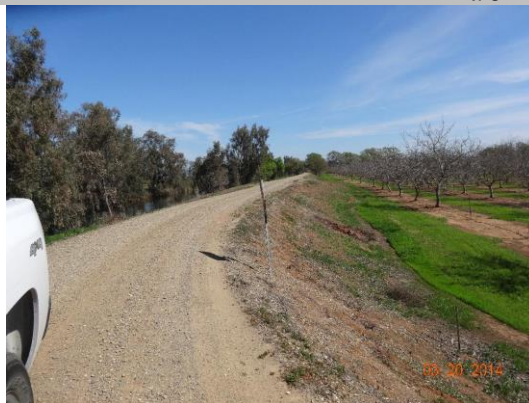
Photo 1 of 3 : UCIP_SP_2018_38324_69864.jpg

FS_ID:38324
DS_ID:19470
EP_NO: 789
Repair Type: Non-Urgent
Crossing Status: Indicator Found
UCIP Comments: Need to contact owner to determine status of crossing. Need date of last inspection and confirmation that crossing is still in operable condition.
FIELD_STRUCT_DESC: 16-inch steel gas line through levee, 3 feet below the crown. Concrete inspection chamber (24-inch by 18-inch box with 4-inch walls) on the waterside (WS) shoulder, covered with dirt. Gas line marker on landside (LS) slope. Extends underneath Dry Creek channel, covered with concrete slab approximately 18-inches wide. (8.625-inch gas line authorized under Permit No. 789, 1939-Pacific Gas and Electric Company [PG&E]). [Additional Reference(s): DWR Levee Logs, 2005, 16-inch gas line. USACE Sacramento O&M Manual Unit No. 146, November 1962, (HLM 0.63), 16-inch gas line]
FS Date: 3/20/2014

View of levee crown looking upstream.

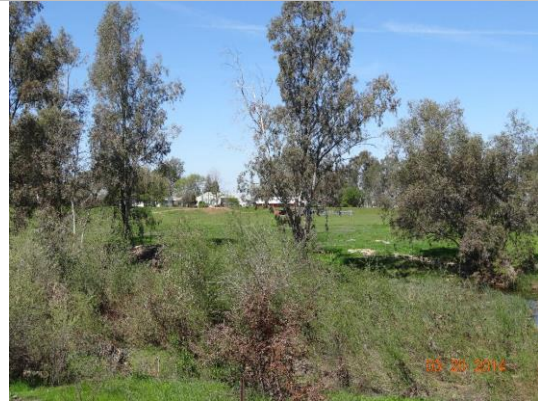
Photo 3 of 3 : UCIP_SP_2018_38324_69862.jpg

Comment Code						
Inspector Comment						
FS_ID:38324 DS_ID:19470 EP_NO: 789 Repair Type: Non-Urgent Crossing Status: Indicator Found UCIP Comments: Need to contact owner to determine status of crossing. Need date of last inspection and confirmation that crossing is still in operable condition. FIELD_STRUCT_DESC: 16-inch steel gas line through levee, 3 feet below the crown. Concrete inspection chamber (24-inch by 18-inch box with 4-inch walls) on the waterside (WS) shoulder, covered with dirt. Gas line marker on landside (LS) slope. Extends underneath Dry Creek channel, covered with concrete slab approximately 18-inches wide. (8.625-inch gas line authorized under Permit No. 789, 1939-Pacific Gas and Electric Company [PG&E]). [Additional Reference(s): DWR Levee Logs, 2005, 16-inch gas line. USACE Sacramento O&M Manual Unit No. 146, November 1962, (HLM 0.63), 16-inch gas line] FS Date: 3/20/2014

Overview of gas marker visible on opposite bank.

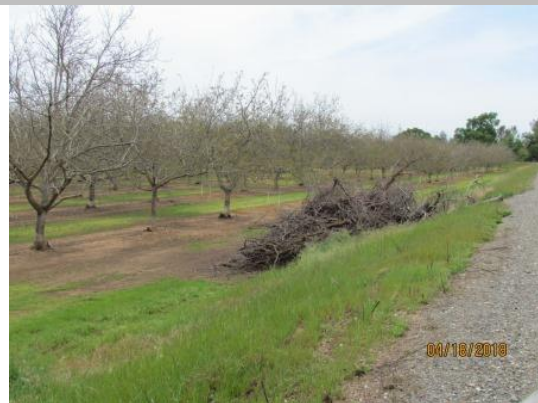
Photo 1 of 1 : SP_2018_RD2103_10_27_20180501_00049.jpg

View looking downstream landside of pruning's on the levee slope, Spring 2018.

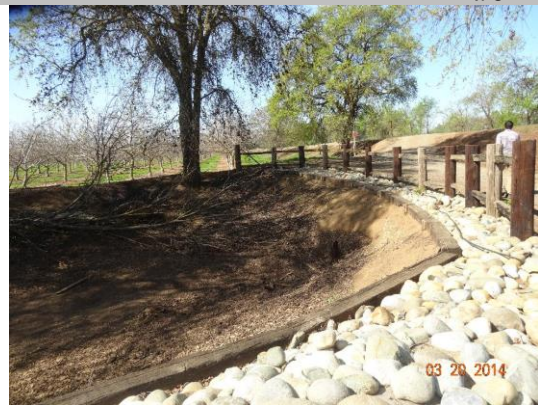
Photo 1 of 3 : UCIP_SP_2018_38325_69869.jpg

LM Start	0.82	Rating **	A/W	Issue No.	36
LM End	0.82	Issue Type +	Ma	Location *	
Category	Supplemental			GPS Latitude/Longitude	
				Start	End
Item	DWR UCIP LMA Responsibility			39.024811 °	39.024811 °
				-121.440750 °	-121.440750 °
DWR ID					
Comment Code					
Inspector Comment					
FS_ID:38325					
DS_ID:19471					
EP_NO: N/A					
Repair Type: No Action Needed					
Crossing Status: Found					
UCIP Comments:					
FIELD_STRUCT_DESC: 36-inch corrugated metal drainage pipe through the levee, 14.4 feet below the crown. Concrete headwall, flap-gate, and 3-foot by 6-foot concrete splash apron located on the waterside (WS) toe. Outfall drain from old Grasshopper Slough.					
[Additional Reference(s): DWR Levee Logs, 2005. USACE Sacramento O&M Manual Unit No. 146, November 1962, (HLM 0.83)]					
FS Date: 3/20/2014

View of CMP crossing located on landward side.

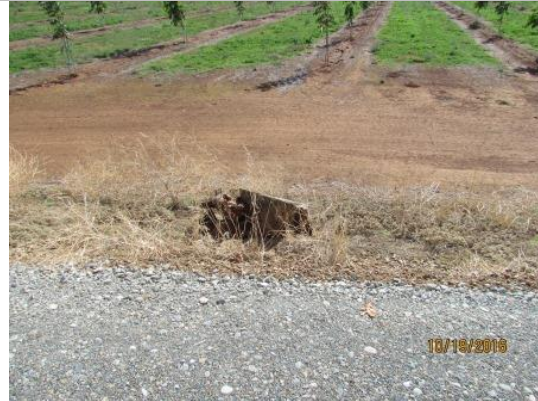
Photo 1 of 1 : SP_2018_RD2103_10_26_20180302_00007.jpg

View of tree stump on lanside levee slope. Fall 2016, still exist as of Fall 2017.

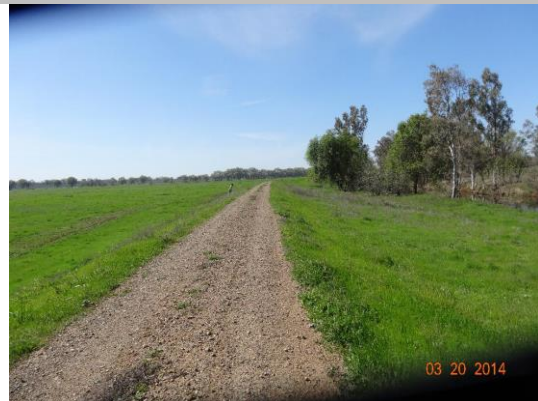
Photo 1 of 3 : UCIP_SP_2018_41183_69917.jpg

Comment Code					
Inspector Comment					
FS_ID:41183 DS_ID:19473 EP_NO: 1886 Repair Type: Non-Urgent Crossing Status: Indicator Found UCIP Comments: Need to coordinate with owner. Severely corroded section of steel pipe present on waterward side--no other evidense present at this location. Owner will need to coordinate with CVFPB and DWR-Inspector to determine proper action to abandon crossing. FIELD_STRUCT_DESC: *ABANDONED* 12-inch steel irrigation pipe through the levee, 3.1 feet below the crown. Siphon breaker on the waterward slope. Concrete standpipe at the landward toe. Vertical pump on waterside (WS). Open on WS end. Permit includes gravel dam through channel of Dry Creek. Crossing is angled 45 degrees. (10-inch pipe authorized under Permit No. 1886, 1959-R. H. Blackford, Jr.) [Additional Reference(s): DWR Levee Logs, 2005. USACE Sacramento O&M Manual Unit No. 146, November 1962, (HLM 1.86)] FS Date: 3/20/2014

Overview of levee crown.

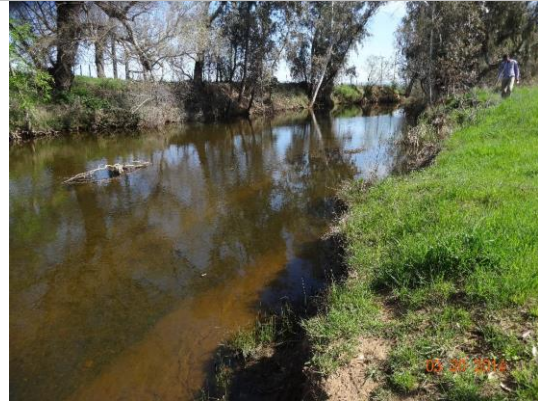
Photo 3 of 3 : UCIP_SP_2018_38327_69879.jpg

LM Start	1.86	Rating **	M	Issue No.	38 (cont)	
LM End	1.86	Issue Type +	En	Location *		
Category	Supplemental			GPS Latitude/Longitude		
				Start	End	
Item	DWR UCIP Field Study			39.029694 °	39.029694 °	
				-121.423946 °	-121.423946 °	
DWR ID						
Comment Code						
Inspector Comment						
FS_ID:38327 DS_ID:19512 EP_NO: N/A Repair Type: Non-Urgent Crossing Status: Indicator Found UCIP Comments: Unable to determine if there is a crossing through pipe. Will need to coordinate with owner to determine additional information about appurtenances found on landward side. FIELD_STRUCT_DESC: Irrigation pump, service pole, and 36-inch concrete standpipe, 5 feet from the landside (LS) toe. No pump was found during field visit 3/20/14. [Additional Reference(s): DWR Levee Logs, 2005] FS Date: 3/20/2014

No crossing visible on waterward side.

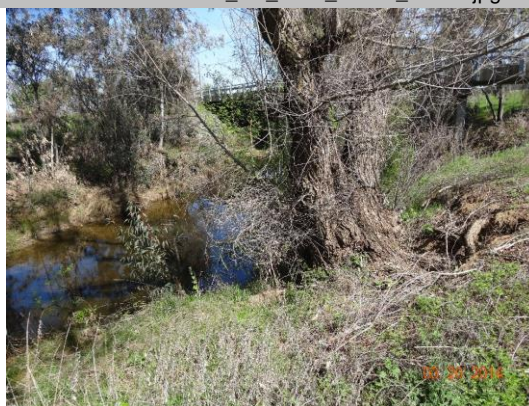
Photo 2 of 3 : UCIP_SP_2018_38331_69893.jpg

LM Start	2.64	Rating **	M	Issue No.	39 (cont)	
LM End	2.64	Issue Type +	En	Location *		
Category	Supplemental			GPS Latitude/Longitude		
				Start		End
Item	DWR UCIP Field Study			39.031590 °		39.031590 °
				-121.409870 °		-121.409870 °
DWR ID						
Comment Code						
Inspector Comment						
FS_ID:38331 DS_ID:19477 EP_NO: N/A Repair Type: Non-Urgent Crossing Status: Found UCIP Comments: Need to contact owner to determine status. FIELD_STRUCT_DESC: 8-inch steel irrigation pipe through the levee, 3.1 feet below the crown. Siphon breaker on the waterward slope. Pump on the landward side. Pipe crosses creek to orchard on north side. (two 12-inch pipes authorized under Permit No. 1887, 1954-H. B. Waltz, HLM 2.41 and 2.68) [Additional Reference(s): DWR Levee Logs, 2005. USACE Sacramento O&M Manual Unit No. 146, November 1962, (HLM 2.68), 8-inch] FS Date: 3/20/2014

Crossing was not visible on waterward side.

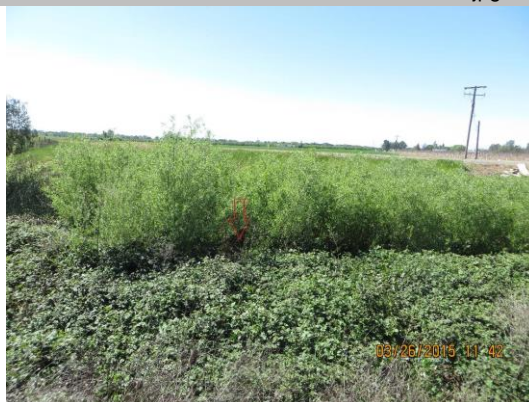
Photo 2 of 3 : UCIP_SP_2018_50033_73428.jpg

Location of pipe and flapgate on WS berm.

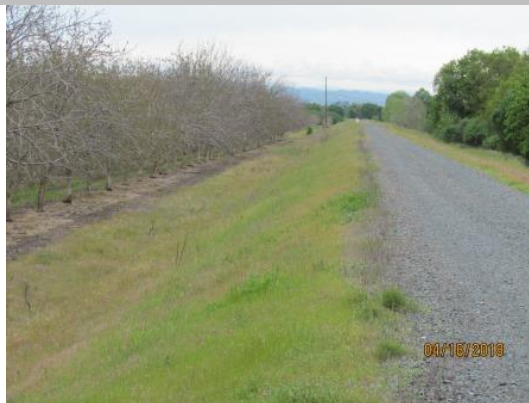
Photo 1 of 1 : SP_2018_RD2103_11_13_20180501_00032.jpg

View looking upstream landside of maintained annual vegetation, Spring 2018.

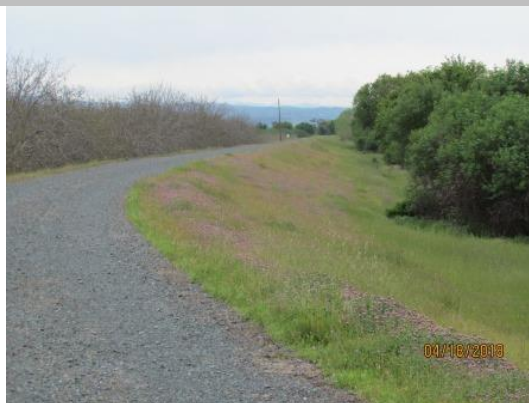
Photo 1 of 1 : SP_2018_RD2103_11_14_20180501_00033.jpg

View looking upstream waterside of maintained annual vegetation, Spring 2018.

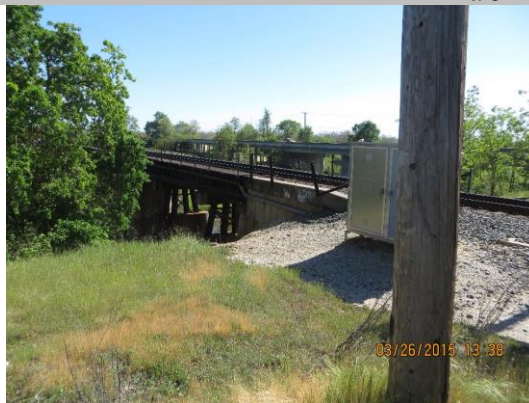
Photo 2 of 3 : UCIP_SP_2018_44089_73567.jpg

6-inch steel conduit visible on upstream side of railroad bridge.

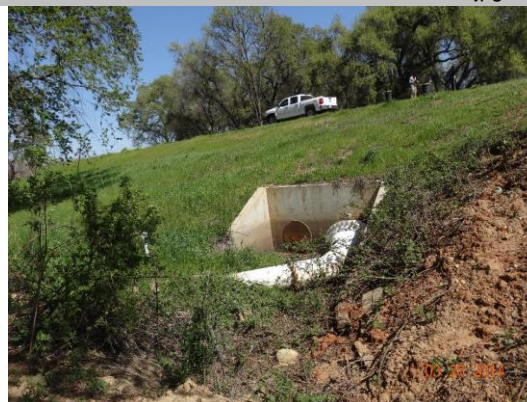
Photo 3 of 3 : UCIP_SP_2018_40046_71919.jpg

Concrete headwall visible on waterward side--white pipe attached to crossing at headwall.
